Low Horsepower on Komatsu
830E Haul Truck

Reduce Engine Failures and Cut Maintenance Costs on Haul Trucks

A MineCare customer shares how they protect haul truck engines and turbochargers from catastrophic failures with effective use of real-time data, avoiding \$750,000 in maintenance costs in just a few months time.

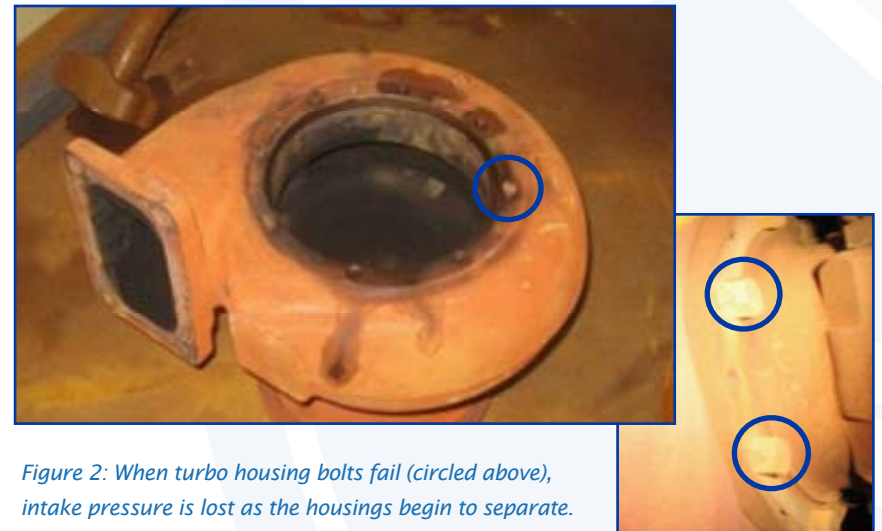
As a precaution, the truck was immediately shut down while the maintenance team analyzed the data sent to them by the MineCare attendant from a remote monitoring center. Using that data, the breakdown crew knew exactly where to look as they inspected the engine, quickly confirming that bolts had broken on the snail casing of the right-hand turbocharger. The casing had begun to separate from the turbine cover (Figure 2) resulting in a loss of horsepower.

Figure 2: When turbo housing bolts fail (circled above), intake pressure is lost as the housings begin to separate.

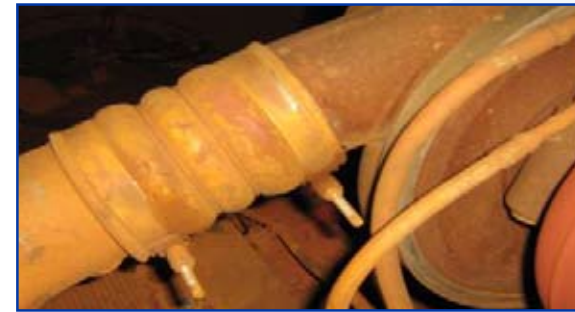
The breakdown crew found that a hose between the turbocharger and aftercooler had detached, preventing the compressed air from reaching the right bank of cylinders and elevating their temperatures. This leak also caused the original low boost pressure alarm. The breakdown crew fitted a new hose and clamp to the turbocharger (Figure 5), and the truck was immediately sent back to work.

Figure 5: Example of the hose that detached from the turbocharger and aftercooler.

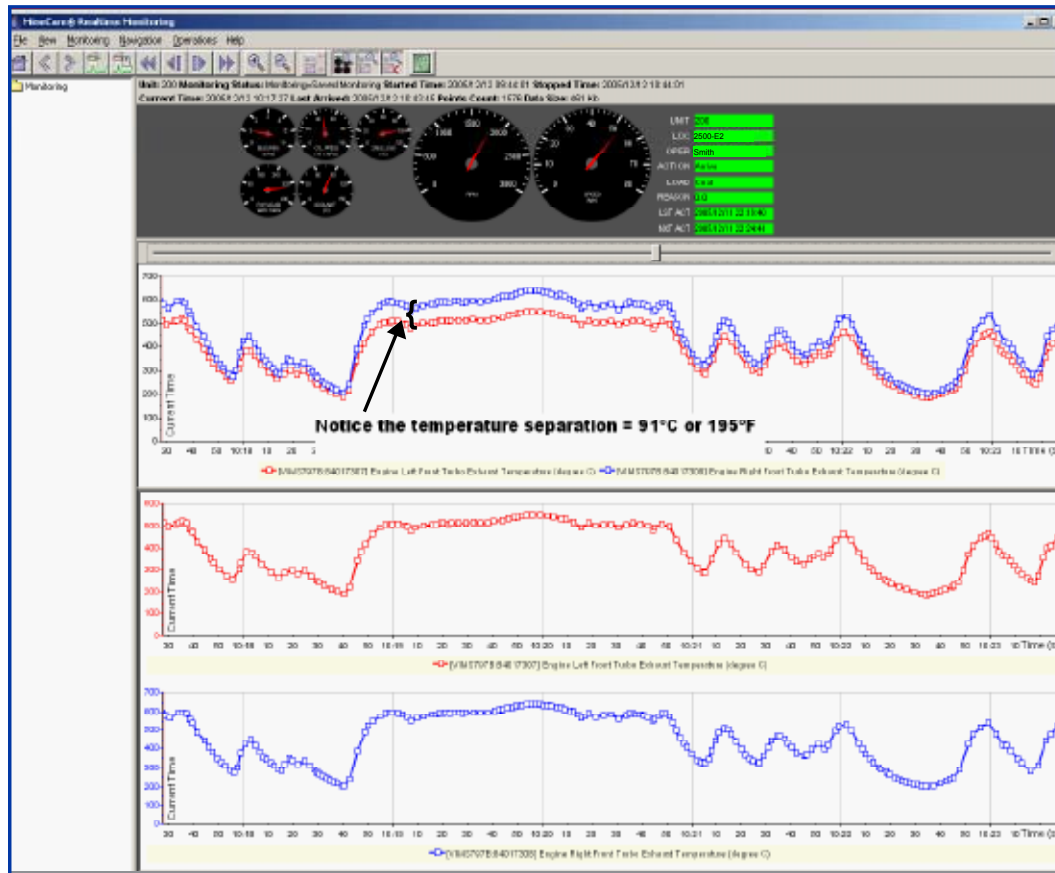
A similar defect related to boost air pressure was observed on another truck engine, and the RTM feature was used to validate the exhaust temperature. Figure 6 is shown below for comparison with Case 2, and for general informational purposes highlighting the capabilities of the MineCare system.

Figure 6: Example of how the MineCare system can be used to prevent a turbocharger defect by monitoring exhaust temperature differential.

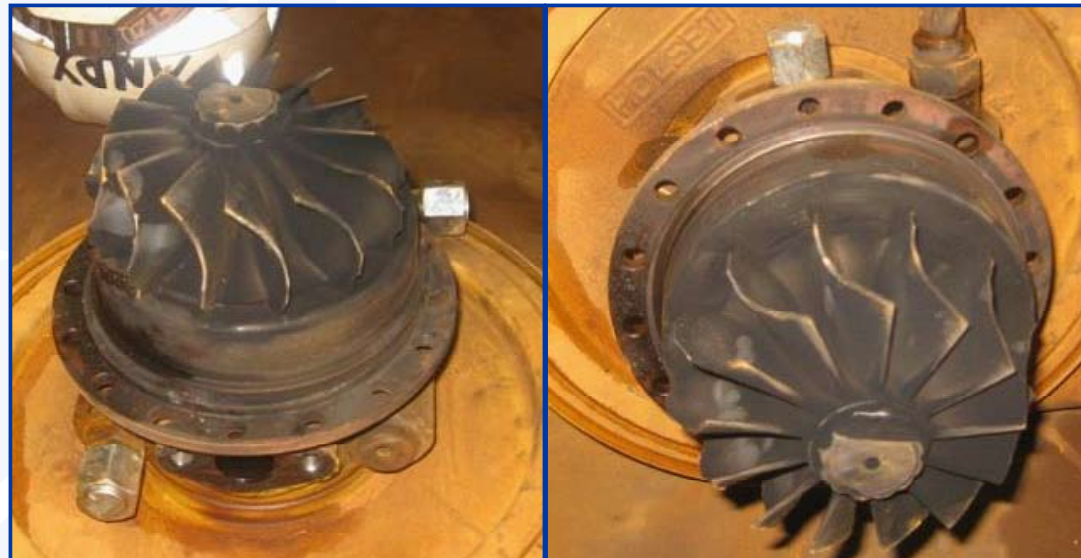
Upon analysis of the snapshot data, the MineCare system attendant requested the problem truck to park up in a safe place immediately. The breakdown crew found that the turbocharger had failed due to several bolt failures on the snail housing, causing the turbine vanes and the turbine housing to come into contact (Figure 7).

*Figure 7:
The dismantled turbocharger's turbine vanes are exposed, showing the damage they suffered during the incident.*

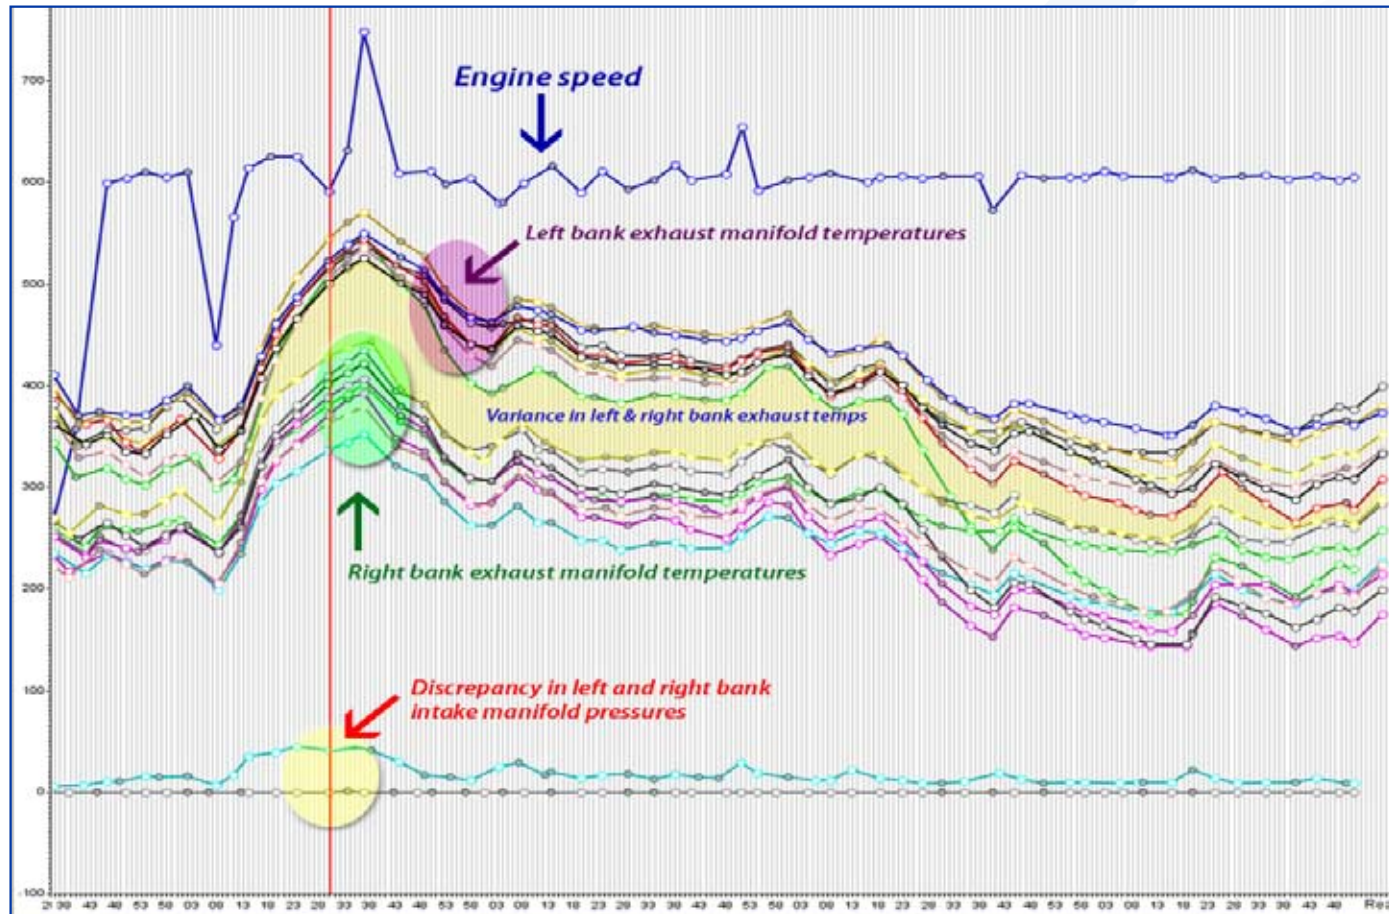
The snapshot captured by the mine's maintenance team (Figure 8), displays left and right bank exhaust temperatures with the difference between them shaded in yellow. Purple and green colored ovals highlight the two different groups of exhaust temperatures. Similarly, the yellow circle near the X-axis highlights the difference in boost air pressure of each side of the intake manifold.

Figure 8:
Snapshot of exhaust
temperature and
intake manifold
pressure differential.
The gap between right
and left bank exhaust
is highlighted in yellow.
